**CITY OF ROCKVILLE HISTORIC DISTRICT COMMISSION  
STAFF REPORT**

**September 10, 2003  
MEETING NO. 10-03**

**APPLICATION:** HDC03-0257

**REQUEST:** The Applicant requests a Certificate of Approval to remove a 53-inch DBH (diameter at breast height) white oak, located in the driveway.

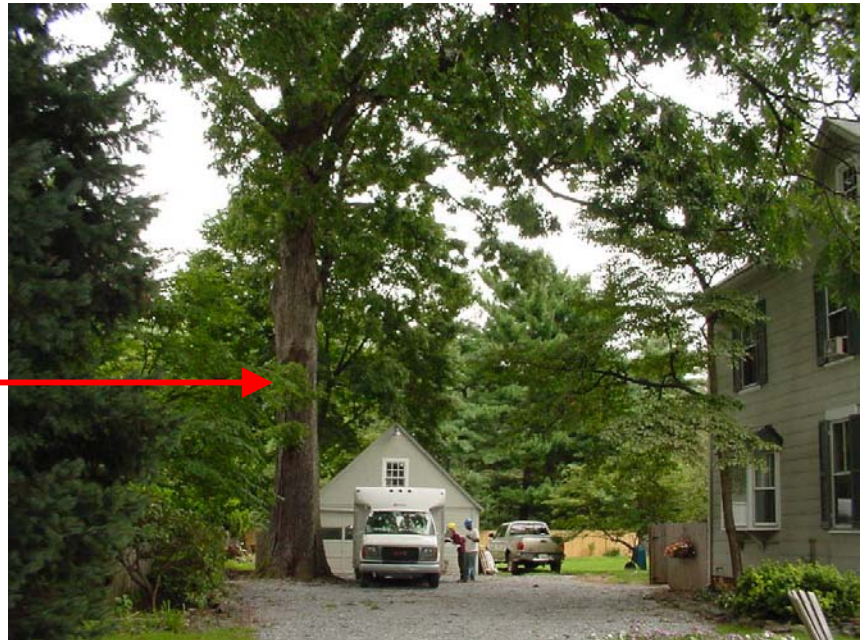
1. The tree has a “noticeable lean” toward “high profile targets”, specifically the neighbor’s house and the neighbor’s mature white oak;
2. The tree’s canopy is off balance with overweight limbs; and
3. There is decay along the back side of the tree which may be evidence of an old lightening strike.

White Oak proposed  
for removal

Staff recommends that the HDC approve removal of the white oak due to its potentially hazardous condition as assessed by the tree care specialist and replacement with three 2 ½-inch caliper oak trees, per the City Forester's recommendation. Pruning major limbs of the tree's canopy, periodically monitoring the tree's condition, and realignment of the driveway to accommodate the tree are other options the Applicant might consider.

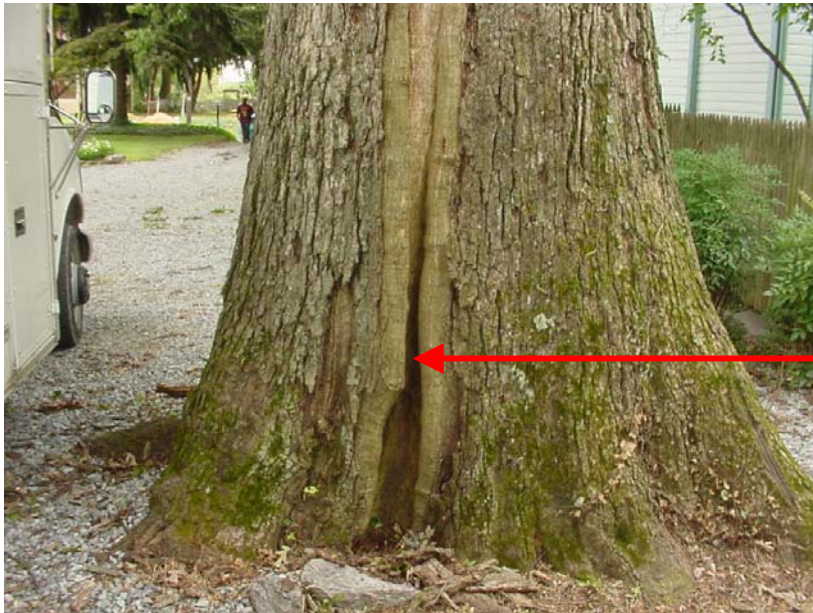
Evidence of lightning strike  
and decay

The City Forester also inspected the tree and found that it looks healthy and does not appear to present an immediate hazard. However, she agreed that it does lean toward the neighbor's house and there is some decay on the opposite side of the lean direction. She noted that a tree with a strength loss percentage of less than 33% should be fairly stable, but severe storms and high wind speeds have taken out healthier trees. She recommends replacement with three 2 ½-inch caliper oak trees.
